Issue detail

Created on	Nov 5, 2026, 9:41 PM PST
Created by	**Gracie Wallace** (F26-CEE120A_220A)
Total items	10
Sorted by	ID (Ascending)
Filtered by	Created on (Oct 29, 2026 - Nov 5, 2026)

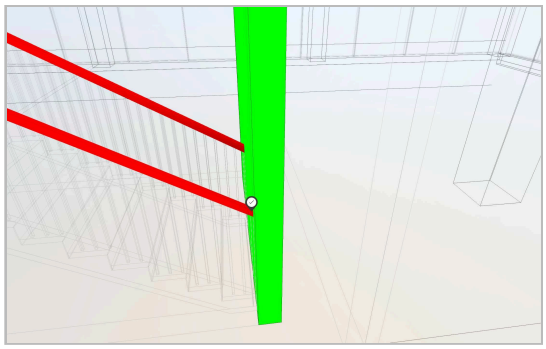
#1: Cantilever wall too close to stair

Status	**Open**
Type	CL Coordination > Clash
ID	#1
Description	11 total clashes: 1 clash between Top Rail Type [390264] in Wallace - Building Module 6 ARCH.rvt - 3D - ARCHITECTURE COORDINATION and Wallace-Building Module 6 STRUC.rvt - 3D - STRUCTURAL COORDINATION 1 clash between Top Rail Type [390276] in Wallace - Building Module 6 ARCH.rvt - 3D - ARCHITECTURE COORDINATION and Wallace-Building Module 6 STRUC.rvt - 3D - STRUCTURAL COORDINATION 1 clash between Top Rail Type [390358] in Wallace - Building Module 6 ARCH.rvt - 3D - ARCHITECTURE COORDINATION and Wallace-Building Module 6 STRUC.rvt - 3D - STRUCTURAL COORDINATION 1 clash between Top Rail Type [390466] in Wallace - Building Module 6 ARCH.rvt - 3D - ARCHITECTURE COORDINATION and Wallace-Building Module 6 STRUC.rvt - 3D - STRUCTURAL COORDINATION 1 clash between Top Rail Type [390574] in Wallace - Building Module 6 ARCH.rvt - 3D - ARCHITECTURE COORDINATION and Wallace-Building Module 6 STRUC.rvt - 3D - STRUCTURAL COORDINATION 1 clash between Top Rail Type [390895] in Wallace - B...

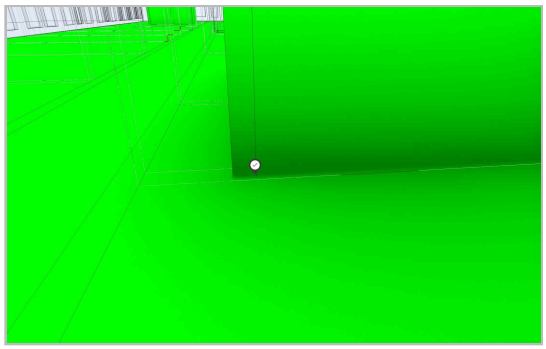
#2: Cantilever walls too close to stairs

Description	59 total clashes: 8 clashes between Assembled Stair [390215] in Wallace - Building Module 6 ARCH.rvt - 3D - ARCHITECTURE COORDINATION and Wallace-Building Module 6 STRUC.rvt - 3D - STRUCTURAL COORDINATION 5 clashes between Assembled Stair [390323] in Wallace - Building Module 6 ARCH.rvt - 3D - ARCHITECTURE COORDINATION and Wallace-Building Module 6 STRUC.rvt - 3D - STRUCTURAL COORDINATION 5 clashes between Assembled Stair [390431] in Wallace - Building Module 6 ARCH.rvt - 3D - ARCHITECTURE COORDINATION and Wallace-Building Module 6 STRUC.rvt - 3D - STRUCTURAL COORDINATION 5 clashes between Assembled Stair [390539] in Wallace - Building Module 6 ARCH.rvt - 3D - ARCHITECTURE COORDINATION and Wallace-Building Module 6 STRUC.rvt - 3D - STRUCTURAL COORDINATION 8 clashes between Assembled Stair [390834] in Wallace - Building Module 6 ARCH.rvt - 3D - ARCHITECTURE COORDINATION and Wallace-Building Module 6 STRUC.rvt - 3D - STRUCTURAL COORDINATION 5 clashes between Assembled Stair...

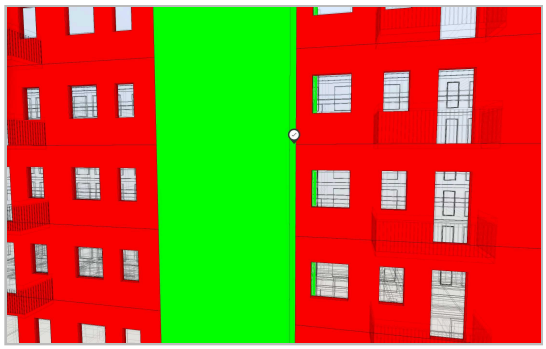
#3: Elevator shaft interferes with facade

Status	**Open**
Type	CL Coordination > Clash
ID	#3
Description	12 total clashes: 2 clashes between Basic Wall [376860] in Wallace - Building Module 6 ARCH.rvt - 3D - ARCHITECTURE COORDINATION and Wallace-Building Module 6 STRUC.rvt - 3D - STRUCTURAL COORDINATION 2 clashes between Basic Wall [376864] in Wallace - Building Module 6 ARCH.rvt - 3D - ARCHITECTURE COORDINATION and Wallace-Building Module 6 STRUC.rvt - 3D - STRUCTURAL COORDINATION 2 clashes between Basic Wall [376869] in Wallace - Building Module 6 ARCH.rvt - 3D - ARCHITECTURE COORDINATION and Wallace-Building Module 6 STRUC.rvt - 3D - STRUCTURAL COORDINATION 2 clashes between Basic Wall [376872] in Wallace - Building Module 6 ARCH.rvt - 3D - ARCHITECTURE COORDINATION and Wallace-Building Module 6 STRUC.rvt - 3D - STRUCTURAL COORDINATION 2 clashes between Basic Wall [376876] in Wallace - Building Module 6 ARCH.rvt - 3D - ARCHITECTURE COORDINATION and Wallace-Building Module 6 STRUC.rvt - 3D - STRUCTURAL COORDINATION 2 clashes between Basic Wall [376882] in Wallace - Buildin...

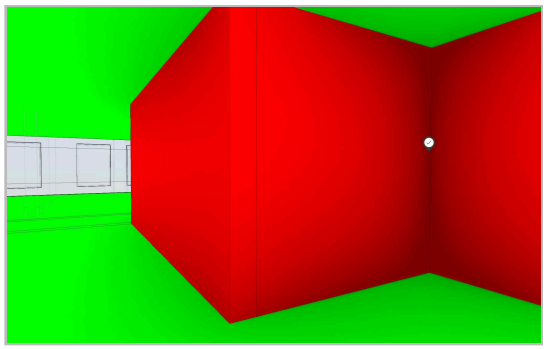
#4: Interior walls intersecting shaft structural walls

Status	**Open**
Type	CL Coordination > Clash
ID	#4
Description	85 total clashes: 4 clashes between Basic Wall [376890] in Wallace - Building Module 6 ARCH.rvt - 3D - ARCHITECTURE COORDINATION and Wallace-Building Module 6 STRUC.rvt - 3D - STRUCTURAL COORDINATION 3 clashes between Basic Wall [376891] in Wallace - Building Module 6 ARCH.rvt - 3D - ARCHITECTURE COORDINATION and Wallace-Building Module 6 STRUC.rvt - 3D - STRUCTURAL COORDINATION 4 clashes between Basic Wall [376892] in Wallace - Building Module 6 ARCH.rvt - 3D - ARCHITECTURE COORDINATION and Wallace-Building Module 6 STRUC.rvt - 3D - STRUCTURAL COORDINATION 4 clashes between Basic Wall [376893] in Wallace - Building Module 6 ARCH.rvt - 3D - ARCHITECTURE COORDINATION and Wallace-Building Module 6 STRUC.rvt - 3D - STRUCTURAL COORDINATION 2 clashes between Basic Wall [376894] in Wallace - Building Module 6 ARCH.rvt - 3D - ARCHITECTURE COORDINATION and Wallace-Building Module 6 STRUC.rvt - 3D - STRUCTURAL COORDINATION 4 clashes between Basic Wall [376895] in Wallace - Buildin...

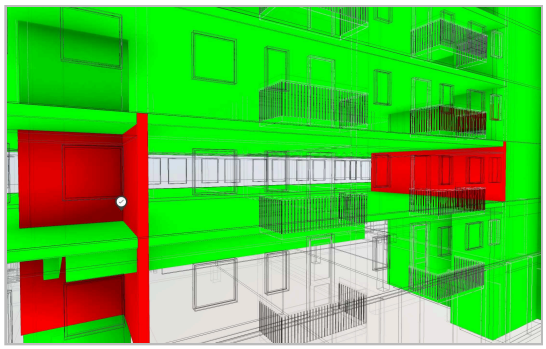
#5: Interior walls intersecting shaft structural walls

Status	**Open**
Type	CL Coordination > Clash
ID	#5
Description	83 total clashes: 2 clashes between Basic Wall [376954] in Wallace - Building Module 6 ARCH.rvt - 3D - ARCHITECTURE COORDINATION and Wallace-Building Module 6 STRUC.rvt - 3D - STRUCTURAL COORDINATION 4 clashes between Basic Wall [376955] in Wallace - Building Module 6 ARCH.rvt - 3D - ARCHITECTURE COORDINATION and Wallace-Building Module 6 STRUC.rvt - 3D - STRUCTURAL COORDINATION 4 clashes between Basic Wall [376956] in Wallace - Building Module 6 ARCH.rvt - 3D - ARCHITECTURE COORDINATION and Wallace-Building Module 6 STRUC.rvt - 3D - STRUCTURAL COORDINATION 4 clashes between Basic Wall [376957] in Wallace - Building Module 6 ARCH.rvt - 3D - ARCHITECTURE COORDINATION and Wallace-Building Module 6 STRUC.rvt - 3D - STRUCTURAL COORDINATION 2 clashes between Basic Wall [376958] in Wallace - Building Module 6 ARCH.rvt - 3D - ARCHITECTURE COORDINATION and Wallace-Building Module 6 STRUC.rvt - 3D - STRUCTURAL COORDINATION 4 clashes between Basic Wall [376963] in Wallace - Buildin...

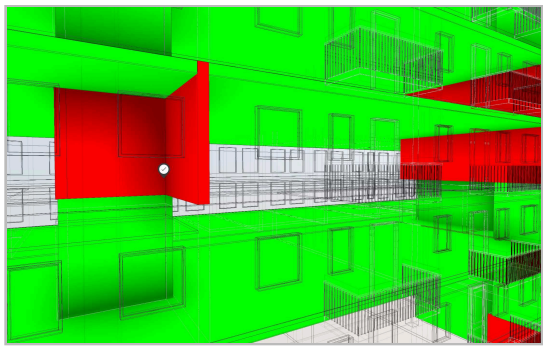
#6: Interior walls intersecting shaft structural walls

Status	**Open**
Type	CL Coordination > Clash
ID	#6
Description	64 total clashes: 4 clashes between Basic Wall [377002] in Wallace - Building Module 6 ARCH.rvt - 3D - ARCHITECTURE COORDINATION and Wallace-Building Module 6 STRUC.rvt - 3D - STRUCTURAL COORDINATION 3 clashes between Basic Wall [377003] in Wallace - Building Module 6 ARCH.rvt - 3D - ARCHITECTURE COORDINATION and Wallace-Building Module 6 STRUC.rvt - 3D - STRUCTURAL COORDINATION 4 clashes between Basic Wall [377007] in Wallace - Building Module 6 ARCH.rvt - 3D - ARCHITECTURE COORDINATION and Wallace-Building Module 6 STRUC.rvt - 3D - STRUCTURAL COORDINATION 3 clashes between Basic Wall [377008] in Wallace - Building Module 6 ARCH.rvt - 3D - ARCHITECTURE COORDINATION and Wallace-Building Module 6 STRUC.rvt - 3D - STRUCTURAL COORDINATION 3 clashes between Basic Wall [377009] in Wallace - Building Module 6 ARCH.rvt - 3D - ARCHITECTURE COORDINATION and Wallace-Building Module 6 STRUC.rvt - 3D - STRUCTURAL COORDINATION 3 clashes between Basic Wall [377013] in Wallace - Buildin...

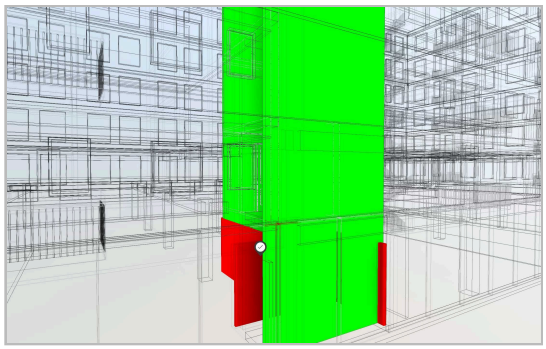
#7: Interior walls intersecting shaft structural walls

Status	**Open**
Type	CL Coordination > Clash
ID	#7
Description	6 total clashes: 1 clash between Basic Wall [579900] in Wallace - Building Module 6 ARCH.rvt - 3D - ARCHITECTURE COORDINATION and Wallace-Building Module 6 STRUC.rvt - 3D - STRUCTURAL COORDINATION 2 clashes between Basic Wall [579954] in Wallace - Building Module 6 ARCH.rvt - 3D - ARCHITECTURE COORDINATION and Wallace-Building Module 6 STRUC.rvt - 3D - STRUCTURAL COORDINATION 3 clashes between Basic Wall [580029] in Wallace - Building Module 6 ARCH.rvt - 3D - ARCHITECTURE COORDINATION and Wallace-Building Module 6 STRUC.rvt - 3D - STRUCTURAL COORDINATION
Assigned to	—
Created by	Gracie Wallace (F26-CEE120A_220A)
Created on	Nov 5, 2026
Location	—
Location details	—
Due date	—
Start date	—
Placement	Wallace - Building Module 6 ARCH.rvt

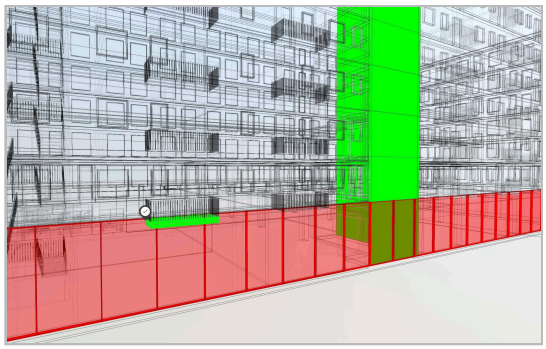
#8: Curtain wall needs to be adjusted for balconies and mech shaft

Status	Open
Type	CL Coordination > Clash
ID	#8
Description	5 total clashes: 1 clash between Curtain Wall [378048] in Wallace - Building Module 6 ARCH.rvt - 3D - ARCHITECTURE COORDINATION and Wallace-Building Module 6 STRUC.rvt - 3D - STRUCTURAL COORDINATION 4 clashes between Curtain Wall [378399] in Wallace - Building Module 6 ARCH.rvt - 3D - ARCHITECTURE COORDINATION and Wallace-Building Module 6 STRUC.rvt - 3D - STRUCTURAL COORDINATION
Assigned to	—
Created by	Gracie Wallace (F26-CEE120A_220A)
Created on	Nov 5, 2026
Location	—
Location details	—
Due date	—
Start date	—
Placement	Wallace - Building Module 6 ARCH.rvt
Root cause	—

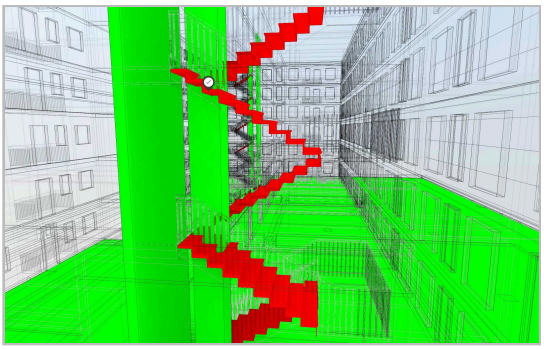
#9: Columns go through stairs

Description	19 total clashes: 1 clash between Non-Monolithic Landing [392904] in Wallace - Building Module 6 ARCH.rvt - 3D - ARCHITECTURE COORDINATION and Wallace-Building Module 6 STRUC.rvt - 3D - STRUCTURAL COORDINATION 1 clash between Non-Monolithic Run [390216] in Wallace - Building Module 6 ARCH.rvt - 3D - ARCHITECTURE COORDINATION and Wallace-Building Module 6 STRUC.rvt - 3D - STRUCTURAL COORDINATION 1 clash between Non-Monolithic Run [390245] in Wallace - Building Module 6 ARCH.rvt - 3D - ARCHITECTURE COORDINATION and Wallace-Building Module 6 STRUC.rvt - 3D - STRUCTURAL COORDINATION 1 clash between Non-Monolithic Run [390324] in Wallace - Building Module 6 ARCH.rvt - 3D - ARCHITECTURE COORDINATION and Wallace-Building Module 6 STRUC.rvt - 3D - STRUCTURAL COORDINATION 1 clash between Non-Monolithic Run [390339] in Wallace - Building Module 6 ARCH.rvt - 3D - ARCHITECTURE COORDINATION and Wallace-Building Module 6 STRUC.rvt - 3D - STRUCTURAL COORDINATION 1 clash between Non-Mono...

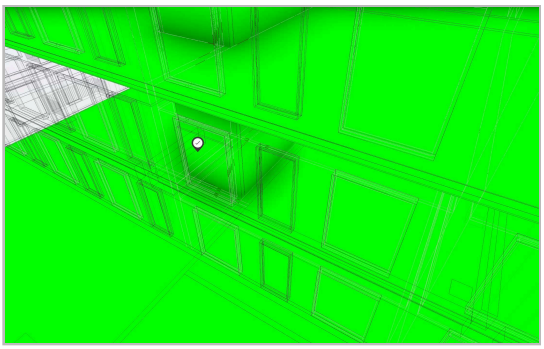
#10: Stairs need some more space - walls overlap with railings and stringers

Status	**Open**
Type	CL Coordination > Clash
ID	#10
Description	79 total clashes: 1 clash between Railing [390253] in Wallace - Building Module 6 ARCH.rvt - 3D - ARCHITECTURE COORDINATION and Wallace-Building Module 6 STRUC.rvt - 3D - STRUCTURAL COORDINATION 1 clash between Railing [390872] in Wallace - Building Module 6 ARCH.rvt - 3D - ARCHITECTURE COORDINATION and Wallace-Building Module 6 STRUC.rvt - 3D - STRUCTURAL COORDINATION 1 clash between Railing [392571] in Wallace - Building Module 6 ARCH.rvt - 3D - ARCHITECTURE COORDINATION and Wallace-Building Module 6 STRUC.rvt - 3D - STRUCTURAL COORDINATION 1 clash between Railing [392575] in Wallace - Building Module 6 ARCH.rvt - 3D - ARCHITECTURE COORDINATION and Wallace-Building Module 6 STRUC.rvt - 3D - STRUCTURAL COORDINATION 1 clash between Railing [392913] in Wallace - Building Module 6 ARCH.rvt - 3D - ARCHITECTURE COORDINATION and Wallace-Building Module 6 STRUC.rvt - 3D - STRUCTURAL COORDINATION 1 clash between Railing [392917] in Wallace - Building Module 6 ARCH.rvt - 3D - ARC...
