Created on	Nov 3, 2026, 6:43 PM PST
Created by	**Anna Chen** (F26-CEE120A_220A)
Total items	1
Sorted by	ID (Ascending)
Filtered by	Created on (Oct 27, 2026 - Nov 3, 2026)

#1: Column Clash with Curtain Wall

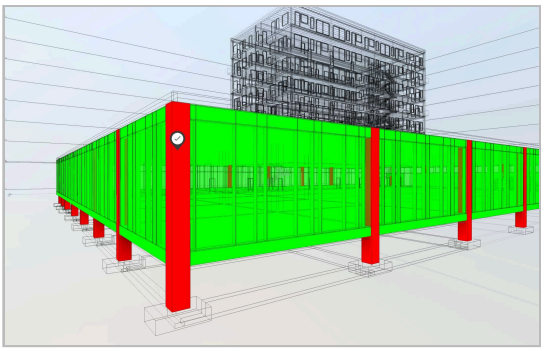
Status	**Open**
Type	CL Coordination > Clash
ID	#1
Description	174 total clashes: 9 clashes between Structural Columns, Concrete-Rectangular-Column [1251742] in Chen-Building-Structural.rvt - 3D - STRUCTURAL COORDINATION and Chen-Building-Module-6.rvt - 3D - ARCHITECTURE - COORDINATION 7 clashes between Structural Columns, Concrete-Rectangular-Column [1251743] in Chen-Building-Structural.rvt - 3D - STRUCTURAL COORDINATION and Chen-Building-Module-6.rvt - 3D - ARCHITECTURE - COORDINATION 8 clashes between Structural Columns, Concrete-Rectangular-Column [1251744] in Chen-Building-Structural.rvt - 3D - STRUCTURAL COORDINATION and Chen-Building-Module-6.rvt - 3D - ARCHITECTURE - COORDINATION 9 clashes between Structural Columns, Concrete-Rectangular-Column [1251745] in Chen-Building-Structural.rvt - 3D - STRUCTURAL COORDINATION and Chen-Building-Module-6.rvt - 3D - ARCHITECTURE - COORDINATION 6 clashes between Structural Columns, Concrete-Rectangular-Column [1251746] in Chen-Building-Structural.rvt - 3D - STRUCTURAL COORDINATION and Chen-Build...
