# Week 6 Clash Report - ISSUES

| **Created by** | **Madison Hunt** (F26-CEE120A_220A) |

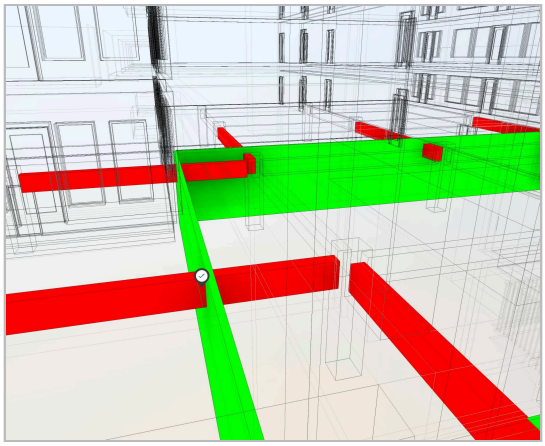
# #4: 8 clashes across 3 Clash Groups

| Description | 8 total clashes:<br><br>4 clashes between Basic Wall [1253927] in HUNT-STRUCTURAL-buildingM6.rvt - 3D STRUCTURAL COORD. and HUNT-ARCH-buildingM6.rvt - 3D - ARCHITECTURAL COORD.<br><br>1 clash between Basic Wall [1254925] in HUNT-STRUCTURAL-buildingM6.rvt - 3D STRUCTURAL COORD. and HUNT-ARCH-buildingM6.rvt - 3D - ARCHITECTURAL COORD.<br><br>3 clashes between Basic Wall [1255078] in HUNT-STRUCTURAL-buildingM6.rvt - 3D STRUCTURAL COORD. and HUNT-ARCH-buildingM6.rvt - 3D - ARCHITECTURAL COORD. |

| M | **Madison Hunt**<br>Nov 3, 2026, 9:22 AM PST | change concrete shaft to ensure can access elevator, mech shaft, etc. |

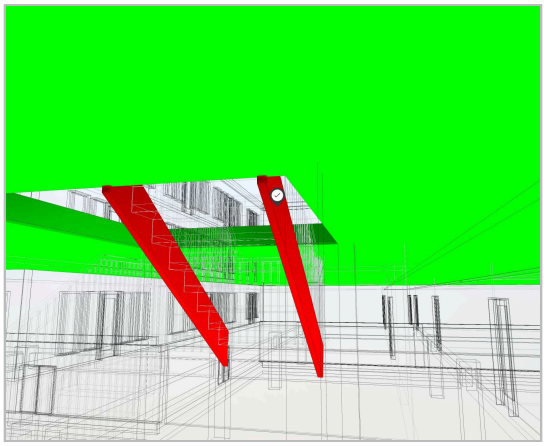
# #3: 49 clashes across 41 Clash Groups

| Description | 49 total clashes:<br><br>1 clash between Concrete-Rectangular Beam [1252588] in HUNT-STRUCTURAL-buildingM6.rvt - 3D STRUCTURAL COORD. and HUNT-ARCH-buildingM6.rvt - 3D - ARCHITECTURAL COORD.<br><br>1 clash between Concrete-Rectangular Beam [1252592] in HUNT-STRUCTURAL-buildingM6.rvt - 3D STRUCTURAL COORD. and HUNT-ARCH-buildingM6.rvt - 3D - ARCHITECTURAL COORD.<br><br>1 clash between Concrete-Rectangular Beam [1252598] in HUNT-STRUCTURAL-buildingM6.rvt - 3D STRUCTURAL COORD. and HUNT-ARCH-buildingM6.rvt - 3D - ARCHITECTURAL COORD.<br><br>1 clash between Concrete-Rectangular Beam [1252602] in HUNT-STRUCTURAL-buildingM6.rvt - 3D STRUCTURAL COORD. and HUNT-ARCH-buildingM6.rvt - 3D - ARCHITECTURAL COORD.<br><br>1 clash between Concrete-Rectangular Beam [1252608] in HUNT-STRUCTURAL-buildingM6.rvt - 3D STRUCTURAL COORD. and HUNT-ARCH-buildingM6.rvt - 3D - ARCHITECTURAL COORD.<br><br>2 clashes between Concrete-Rectangular Beam [1252612] in HUNT-STRUCTURAL-buildingM6.rvt - 3D STRUCTURAL COORD. and HUNT-ARCH-buildingM6.rvt - 3... |

Ensure these clashes are okay. Make changes to location of walls if needed.
