Issue detail

Created on	Nov 2, 2026, 11:36 AM PST
Created by	**Emily Zhu** (F26-CEE120A_220A)
Total items	8
Sorted by	ID (Ascending)
Filtered by	Created on (Oct 26, 2026 - Nov 2, 2026)

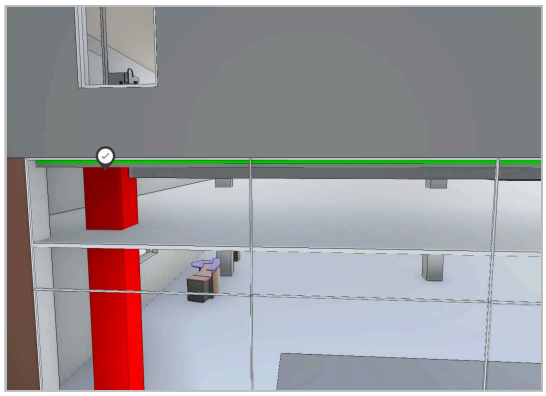
#1: Concrete-Rectangular-Column [1256409] and Compound Ceiling [530186]

Status	Open
Type	CL Coordination > Clash
ID	#1
Description	1 clash between Concrete-Rectangular-Column [1256409] in Module 6_Structural Model.rvt - 3D - Structural Coordination and Module 6_Arch.rvt - 3D - Architectural Coordination Clash between ceiling and concrete columns - potential incorrect ceiling height specified during creation
Assigned to	—
Created by	Emily Zhu (F26-CEE120A_220A)
Created on	Nov 2, 2026
Location	—
Location details	—
Due date	—
Start date	—
Placement	Module 6_Arch.rvt
Root cause	—

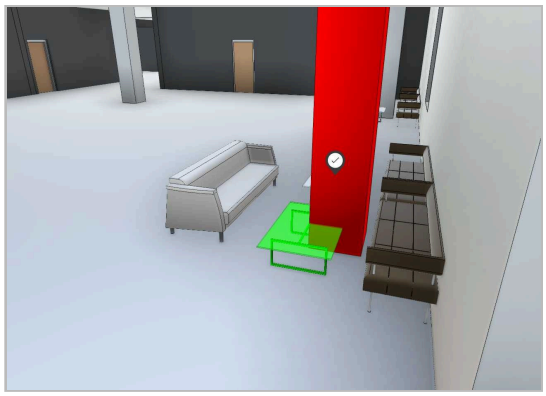
#3: Concrete-Rectangular-Column [1256411] and Table-Coffee Rectangular [560090]

Status	Open
Type	CL Coordination > Clash
ID	#3
Description	1 clash between Concrete-Rectangular-Column [1256411] in Module 6_Structural Model.rvt - 3D - Structural Coordination and Module 6_Arch.rvt - 3D - Architectural Coordination Clash with concrete column and arranged furniture - move sofa and chairs to accommodate for structural column
Assigned to	Emily Zhu (F26-CEE120A_220A)
Created by	Emily Zhu (F26-CEE120A_220A)
Created on	Nov 2, 2026
Location	—
Location details	—
Due date	—
Start date	—
Placement	Module 6_Structural Model.rvt
Root cause	—

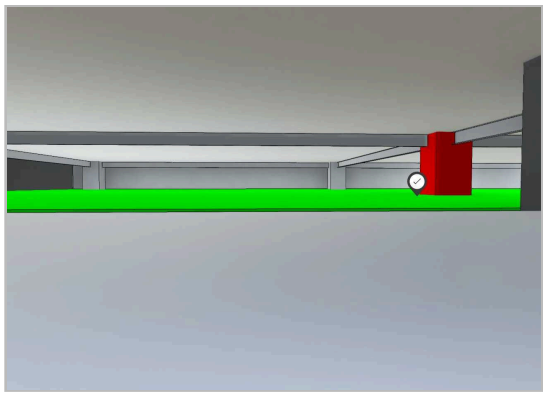
#4: Concrete-Rectangular-Column [1256412] and Table-Coffee Rectangular [560523]

Status	Open
Type	CL Coordination > Clash
ID	#4
Description	1 clash between Concrete-Rectangular-Column [1256412] in Module 6_Structural Model.rvt - 3D - Structural Coordination and Module 6_Arch.rvt - 3D - Architectural Coordination Clash with concrete column and arranged furniture - move sofa and chairs to accommodate for structural column
Assigned to	Emily Zhu (F26-CEE120A_220A)
Created by	Emily Zhu (F26-CEE120A_220A)
Created on	Nov 2, 2026
Location	—
Location details	—
Due date	—
Start date	—
Placement	Module 6_Structural Model.rvt
Root cause	—

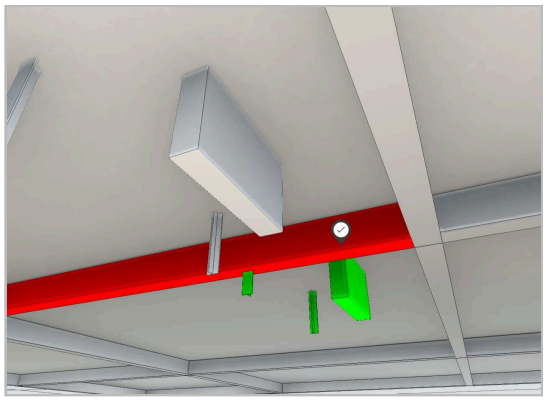
#6: Concrete-Rectangular Beam [1257508] and Otis_Elevator_-_Single_Gen2_3500lb_Capacity_6666 [516845]

Status	Open
Type	CL Coordination > Clash
ID	#6
Description	1 clash between Concrete-Rectangular Beam [1257508] in Module 6_Structural Model.rvt - 3D - Structural Coordination and Module 6_Arch.rvt - 3D - Architectural Coordination Concrete beam clash with bottom of elevators, change offset of elevators or shift slightly to resolve
Assigned to	Emily Zhu (F26-CEE120A_220A)
Created by	Emily Zhu (F26-CEE120A_220A)
Created on	Nov 2, 2026
Location	—
Location details	—
Due date	—
Start date	—
Placement	Module 6_Structural Model.rvt
Root cause	—

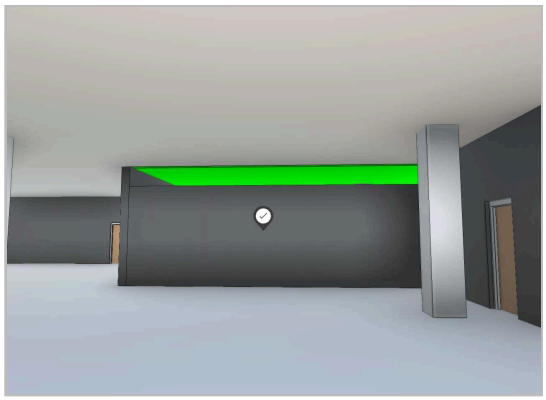
#7: Concrete-Rectangular-Column [1256416] and 2 other objects.

Status	Open
Type	CL Coordination > Clash
ID	#7
Description	2 clashes between Concrete-Rectangular-Column [1256416] in Module 6_Structural Model.rvt - 3D - Structural Coordination and Module 6_Arch.rvt - 3D - Architectural Coordination wall doesn't fully extend up to ceiling
Assigned to	Emily Zhu (F26-CEE120A_220A)
Created by	Emily Zhu (F26-CEE120A_220A)
Created on	Nov 2, 2026
Location	—
Location details	—
Due date	—
Start date	—
Placement	Module 6_Arch.rvt
Root cause	—

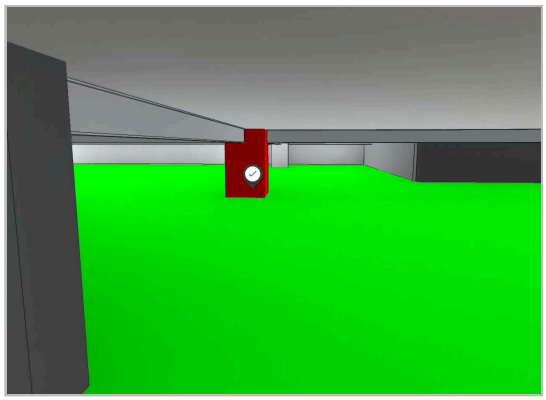
#8: Concrete-Rectangular-Column [1256424] and 2 other objects.

Status	Open
Type	CL Coordination > Clash
ID	#8
Description	2 clashes between Concrete-Rectangular-Column [1256424] in Module 6_Structural Model.rvt - 3D - Structural Coordination and Module 6_Arch.rvt - 3D - Architectural Coordination column extends above ceiling - check ceiling offset height and column height
Assigned to	—
Created by	Emily Zhu (F26-CEE120A_220A)
Created on	Nov 2, 2026
Location	—
Location details	—
Due date	—
Start date	—
Placement	Module 6_Structural Model.rvt
Root cause	—
