Issue detail

Created on	Nov 2, 2026, 5:06 PM PST
Created by	**AnnaElisa Huynh** (F26-CEE120A_220A)
Total items	10
Sorted by	ID (Ascending)
Filtered by	Created on (Oct 26, 2026 - Nov 2, 2026)

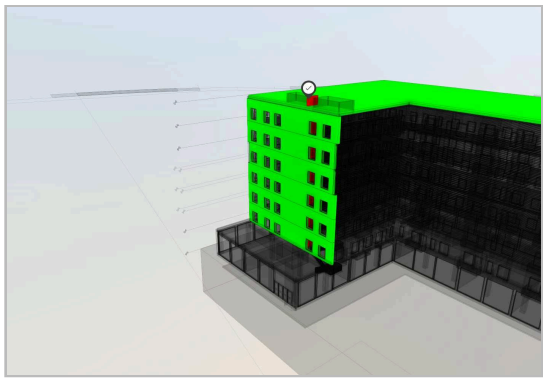
#1: Foundation wall around elevator goes above roof

Status	Open
Type	CL Coordination > Clash
ID	#1
Description	foundation wall rises above roof - 13 clashes between Basic Wall [1264525] in Huynh-Building-Structural-Week6.rvt - 3D - STRUCTURAL COORDINATION and Huynh-Building-Architectural-Week6.rvt - 3D ARCHITECTURAL COORDINATION
Created by	AnnaElisa Huynh (F26-CEE120A_220A)
Location	—
Location details	—
Placement	Huynh-Building-Structural-Week6.rvt
Root cause	—

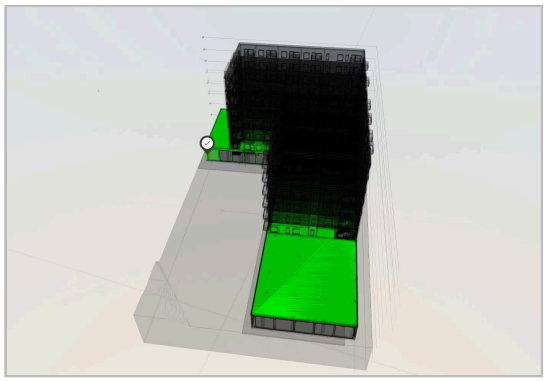
#2: concrete column intersects window wall on first floor

Status	Open
Type	CL Coordination > Clash
ID	#2
Description	4 clashes between Concrete-Rectangular-Column [1262172] in Huynh-Building-Structural-Week6.rvt - 3D - STRUCTURAL COORDINATION and Huynh-Building-Architectural-Week6.rvt - 3D ARCHITECTURAL COORDINATION
Created by	AnnaElisa Huynh (F26-CEE120A_220A)
Location	—
Location details	—
Placement	Huynh-Building-Architectural-Week6.rvt
Root cause	—

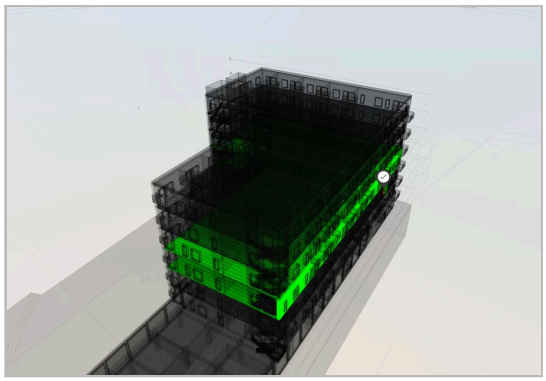
#3: Timber column runs through window in architectural design

Status	**Open**
Type	CL Coordination > Clash
ID	#3
Description	5 total clashes: 3 clashes between Timber-Column [1280438] in Huynh-Building-Structural-Week6.rvt - 3D - STRUCTURAL COORDINATION and Huynh-Building-Architectural-Week6.rvt - 3D ARCHITECTURAL COORDINATION 2 clashes between Timber-Column [1280939] in Huynh-Building-Structural-Week6.rvt - 3D - STRUCTURAL COORDINATION and Huynh-Building-Architectural-Week6.rvt - 3D ARCHITECTURAL COORDINATION
Created by	AnnaElisa Huynh (F26-CEE120A_220A)
Location	—
Location details	—
Placement	Huynh-Building-Structural-Week6.rvt
Root cause	—

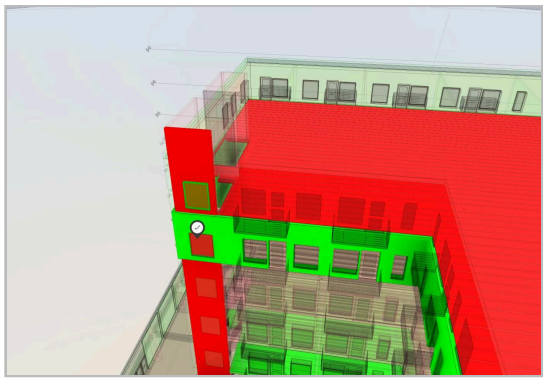
#4: foundation wall conflicted with windows

Status	Open
Type	CL Coordination > Clash
ID	#4
Description	41 total clashes: 1 clash between Basic Wall [1267035] in Huynh-Building-Structural-Week6.rvt - 3D - STRUCTURAL COORDINATION and Huynh-Building-Architectural-Week6.rvt - 3D ARCHITECTURAL COORDINATION 34 clashes between Floor [1248060] in Huynh-Building-Structural-Week6.rvt - 3D - STRUCTURAL COORDINATION and Huynh-Building-Architectural-Week6.rvt - 3D ARCHITECTURAL COORDINATION 6 clashes between TJL Wood Open Web Joist [1276973] in Huynh-Building-Structural-Week6.rvt - 3D - STRUCTURAL COORDINATION and Huynh-Building-Architectural-Week6.rvt - 3D ARCHITECTURAL COORDINATION
Created by	AnnaElisa Huynh (F26-CEE120A_220A)
Location	—
Location details	—
Placement	Huynh-Building-Structural-Week6.rvt
Root cause	—

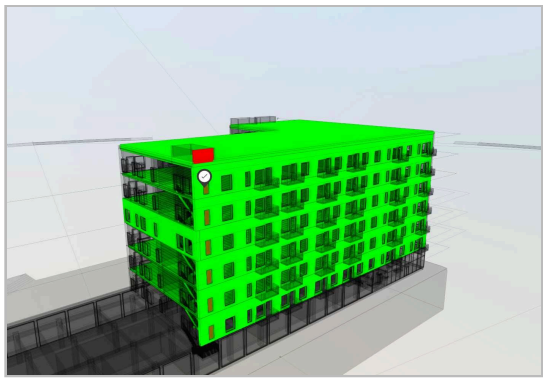
#5: wall blocks off windows

Status	Open
Type	CL Coordination > Clash
ID	#5
Description	26 clashes between Basic Wall [1267629] in Huynh-Building-Structural-Week6.rvt - 3D - STRUCTURAL COORDINATION and Huynh-Building-Architectural-Week6.rvt - 3D ARCHITECTURAL COORDINATION
Created by	AnnaElisa Huynh (F26-CEE120A_220A)
Location	—
Location details	—
Placement	Huynh-Building-Architectural-Week6.rvt
Root cause	—

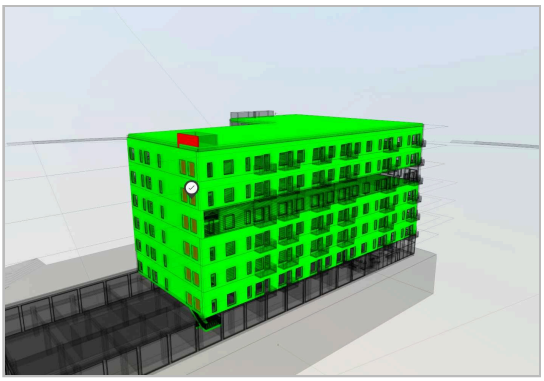
#6: wall conflicts with windows

Status	Open
Type	CL Coordination > Clash
ID	#6
Description	52 clashes between Basic Wall [1267678] in Huynh-Building-Structural-Week6.rvt - 3D - STRUCTURAL COORDINATION and Huynh-Building-Architectural-Week6.rvt - 3D ARCHITECTURAL COORDINATION
Created by	AnnaElisa Huynh (F26-CEE120A_220A)
Location	—
Location details	—
Placement	Huynh-Building-Architectural-Week6.rvt
Root cause	—

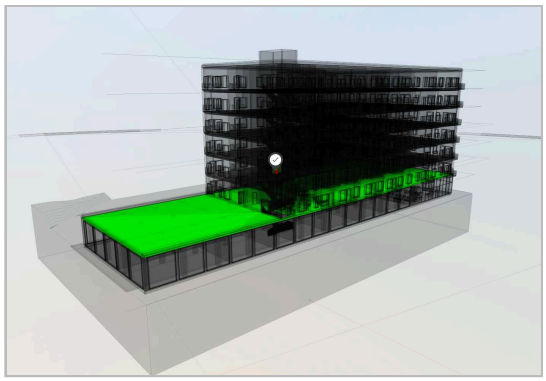
#7: concrete column intersections with floor to ceiling windows

Status	Open
Type	CL Coordination > Clash
ID	#7
Description	2 clashes between Concrete-Rectangular-Column [1262173] in Huynh-Building-Structural-Week6.rvt - 3D - STRUCTURAL COORDINATION and Huynh-Building-Architectural-Week6.rvt - 3D ARCHITECTURAL COORDINATION
Created by	AnnaElisa Huynh (F26-CEE120A_220A)
Location	—
Location details	—
Placement	Huynh-Building-Structural-Week6.rvt
Root cause	—

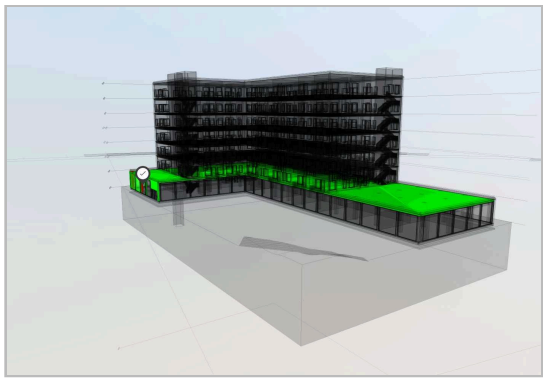
#8: concrete columns intersecting with windows

Status	Open
Type	CL Coordination > Clash
ID	#8
Description	7 total clashes: 5 clashes between Concrete-Rectangular-Column [1262174] in Huynh-Building-Structural-Week6.rvt - 3D - STRUCTURAL COORDINATION and Huynh-Building-Architectural-Week6.rvt - 3D ARCHITECTURAL COORDINATION 2 clashes between Concrete-Rectangular-Column [1262175] in Huynh-Building-Structural-Week6.rvt - 3D - STRUCTURAL COORDINATION and Huynh-Building-Architectural-Week6.rvt - 3D ARCHITECTURAL COORDINATION
Created by	AnnaElisa Huynh (F26-CEE120A_220A)
Location	—
Location details	—
Placement	Huynh-Building-Structural-Week6.rvt
Root cause	—

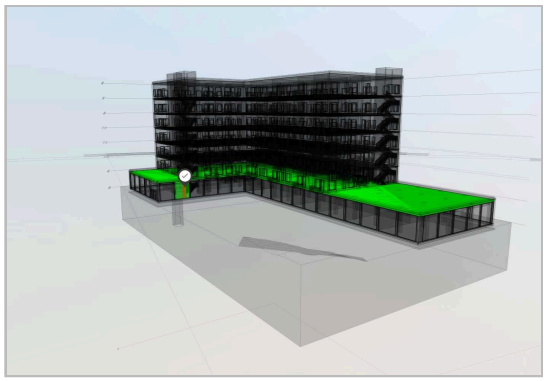
#9: concrete column intersects with window

Status	Open
Type	CL Coordination > Clash
ID	#9
Description	2 clashes between Concrete-Rectangular-Column [1262186] in Huynh-Building-Structural-Week6.rvt - 3D - STRUCTURAL COORDINATION and Huynh-Building-Architectural-Week6.rvt - 3D ARCHITECTURAL COORDINATION
Created by	AnnaElisa Huynh (F26-CEE120A_220A)
Location	—
Location details	—
Placement	Huynh-Building-Architectural-Week6.rvt
Root cause	—

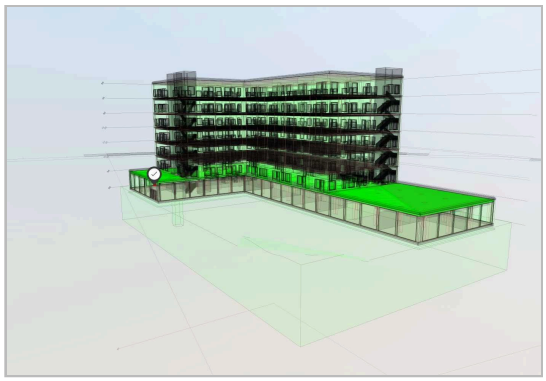
#10: concrete column overlaps with window

Status	Open
Type	CL Coordination > Clash
ID	#10
Description	2 clashes between Concrete-Rectangular-Column [1262188] in Huynh-Building-Structural-Week6.rvt - 3D - STRUCTURAL COORDINATION and Huynh-Building-Architectural-Week6.rvt - 3D ARCHITECTURAL COORDINATION
Created by	AnnaElisa Huynh (F26-CEE120A_220A)
Location	—
Location details	—
Placement	Huynh-Building-Structural-Week6.rvt
Root cause	—
