Issue detail

Created on	Nov 3, 2026, 11:39 PM PST
Created by	**Dominic Tran** (F26-CEE120A_220A)
Total items	3
Sorted by	ID (Ascending)
Filtered by	Created on (Oct 27, 2026 - Nov 3, 2026)

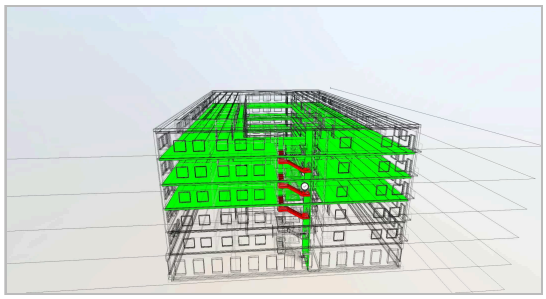
#1: Assembled Stair [387129] and 4 other objects.

Status	Open
Type	CL Coordination > Clash
ID	#1
Description	4 clashes between Assembled Stair [387129] in Forma Building Design - 11-1-2026_detached.rvt - 3D - ARCHITECTURE - COORDINATION and Forma Building Design Structural.rvt - 3D - STRUCTURAL COORDINATION
Assigned to	—
Created by	Dominic Tran (F26-CEE120A_220A)
Created on	Nov 3, 2026
Location	—
Location details	—
Due date	—
Start date	—
Placement	Forma Building Design - 11-1-2026_detached.rvt
Root cause	—

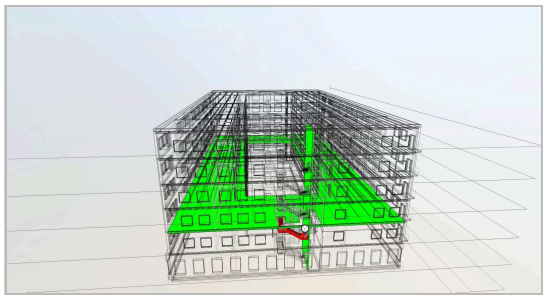
#2: Assembled Stair [391191] and 2 other objects.

Status	Open
Type	CL Coordination > Clash
ID	#2
Description	2 clashes between Assembled Stair [391191] in Forma Building Design - 11-1-2026_detached.rvt - 3D - ARCHITECTURE - COORDINATION and Forma Building Design Structural.rvt - 3D - STRUCTURAL COORDINATION
Assigned to	—
Created by	Dominic Tran (F26-CEE120A_220A)
Created on	Nov 3, 2026
Location	—
Location details	—
Due date	—
Start date	—
Placement	Forma Building Design - 11-1-2026_detached.rvt
Root cause	—

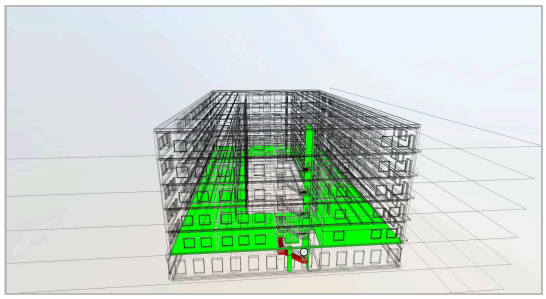
#3: 4 clashes across 2 Clash Groups

Status	**Open**
Type	CL Coordination > Clash
ID	#3
Description	4 total clashes: 3 clashes between Assembled Stair [391766] in Forma Building Design - 11-1-2026_detached.rvt - 3D - ARCHITECTURE - COORDINATION and Forma Building Design Structural.rvt - 3D - STRUCTURAL COORDINATION 1 clash between Assembled Stair [400025] in Forma Building Design - 11-1-2026_detached.rvt - 3D - ARCHITECTURE - COORDINATION and Forma Building Design Structural.rvt - 3D - STRUCTURAL COORDINATION
Assigned to	—
Created by	Dominic Tran (F26-CEE120A_220A)
Created on	Nov 3, 2026
Location	—
Location details	—
Due date	—
Start date	—
Placement	Forma Building Design - 11-1-2026_detached.rvt
Root cause	—
